2016 CAT 563C FELLER BUNCHERS - WHEEL

INSPECTION DETAILS

Inspection Type	Marketing
Inspection Form	Standard
Inspection #	10141250
Inspection Status	Inspected
Created	08/13/24 08:19:13
Updated	08/13/24 14:28:32
Created By	Newman, Joe D.
Inspector	Newman, Joe D.
Salesperson	Dougherty, Daniel E.
Serial #	W6300278
SMU / Hours	6,325

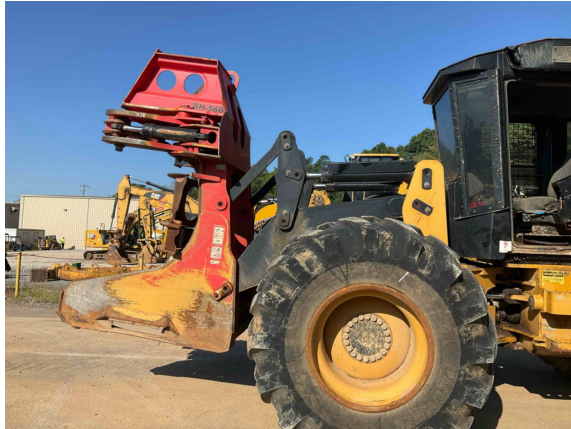
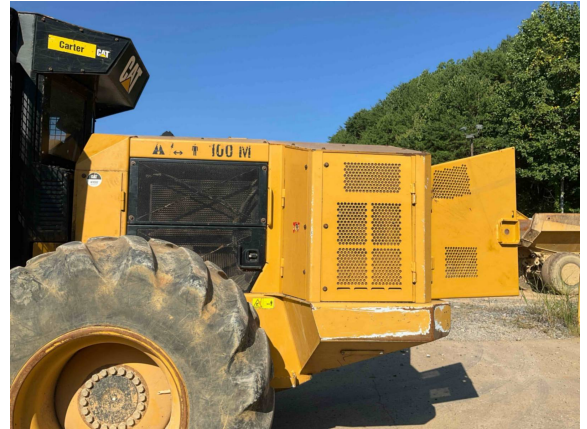
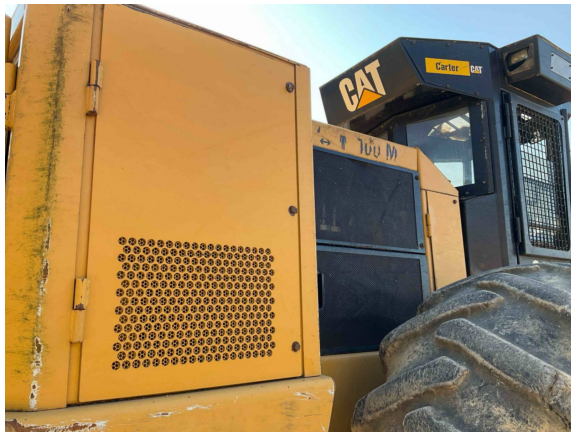
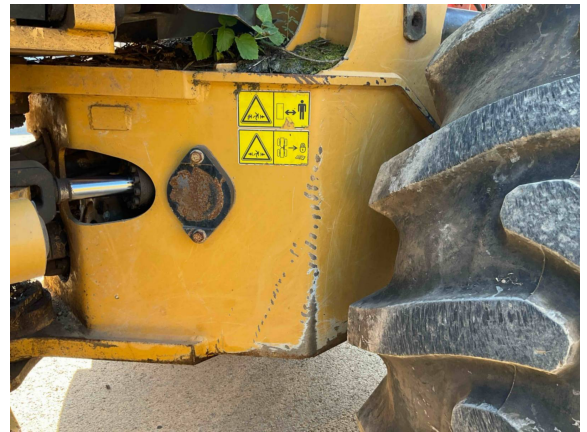
Paint

The paint is faded and scratched throughout.

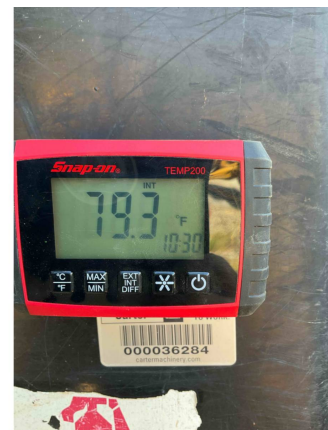
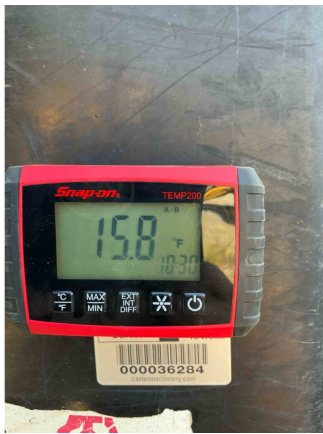
Air Conditioner

Blowing 63 degrees F. Ambient 79 degrees F. There is approximately a 15 degree F. difference.

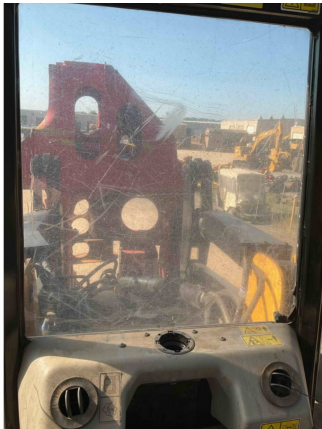
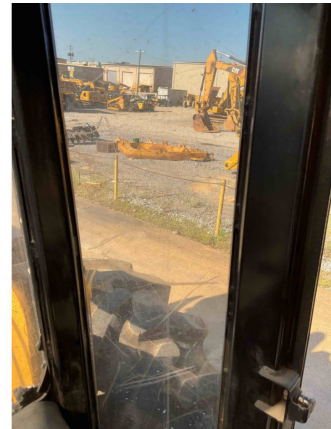
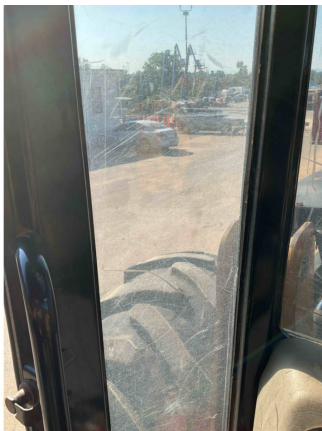
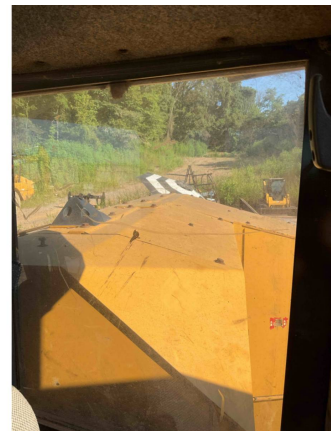
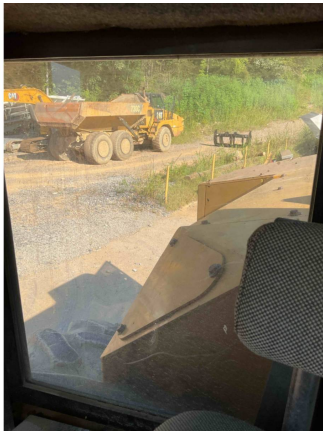
Glass / Mirrors

The side windows are in good condition, the front and back windshields are scratched, and heavily pitted.

●●
The side windows are in good condition, the front and back windshields are scratched, and heavily pitted.

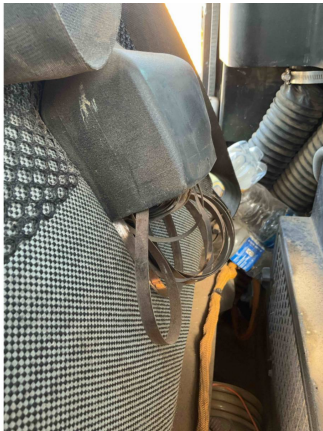
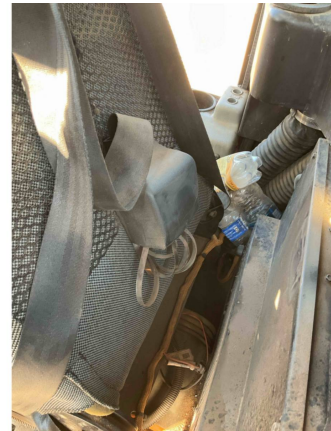
Seat Belt

The back seat belt winding is broken, the seat belt will not retract.

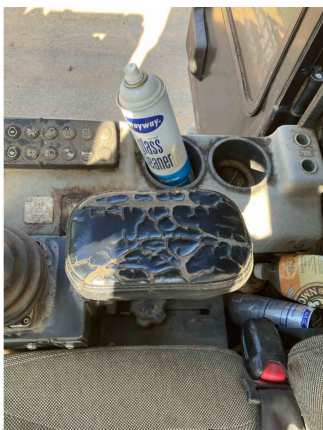
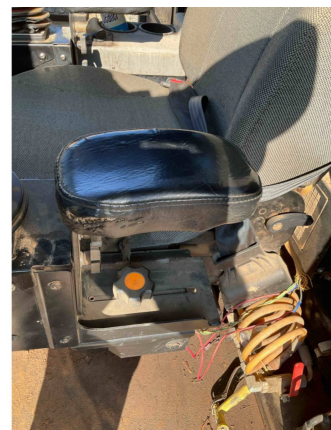
Seat Cushion / Arm Rest

The seat cushions and covers are in good condition, the right side arm rest is heavily cracked, and the left side arm rest has some cracking around the sides.

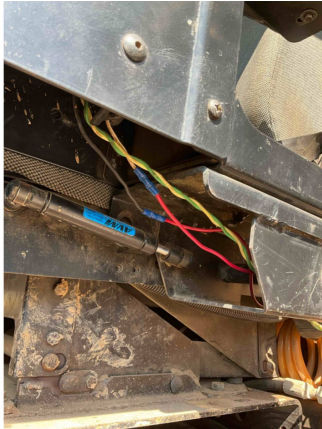
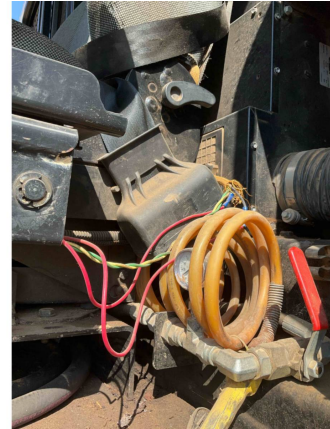
Wiring

2 The wiring for the left side joystick has been repaired, or modified.
Block Heater NO	Ether Aid NO

The wiring for the left side joystick has been repaired, or modified.

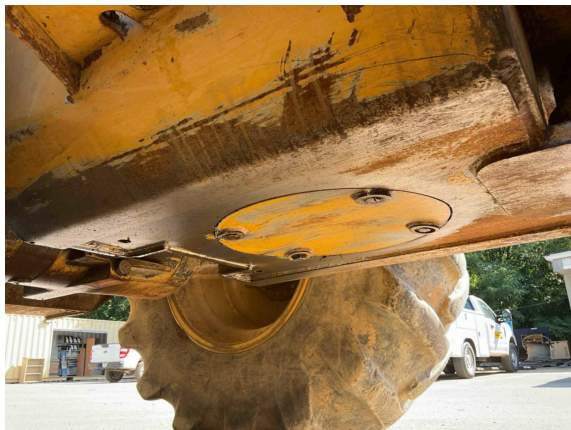
Notes - TRANSMISSION
The belly pan below the transmission is wet, it is unknown if it is a transmission leak or a hydraulic leak.

The belly pan below the transmission is wet, it is unknown if it is a transmission leak or a hydraulic leak.

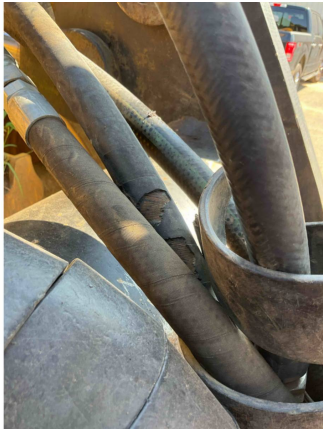
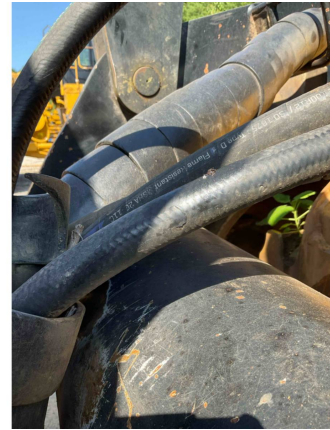
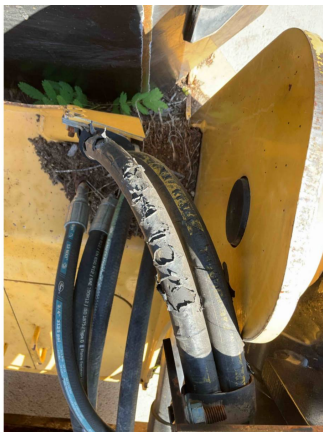
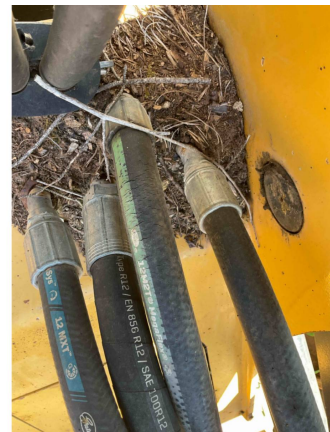
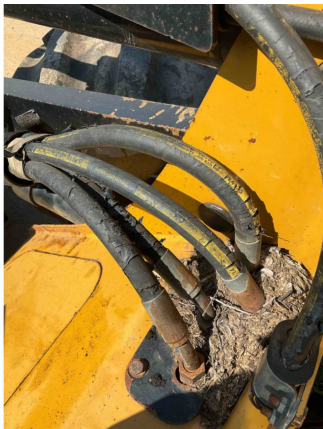
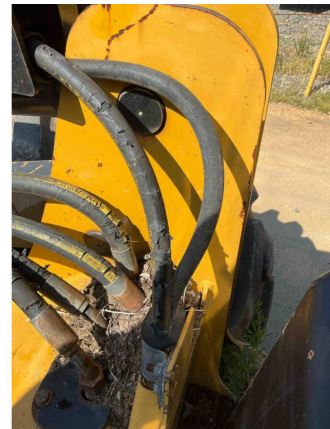
Hose Lines

There are several hoses that are aged and cracking.

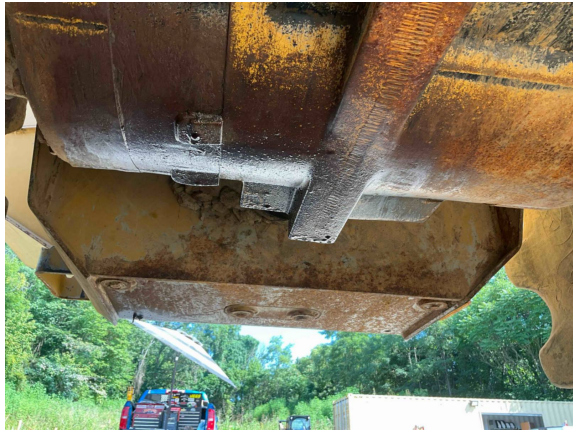
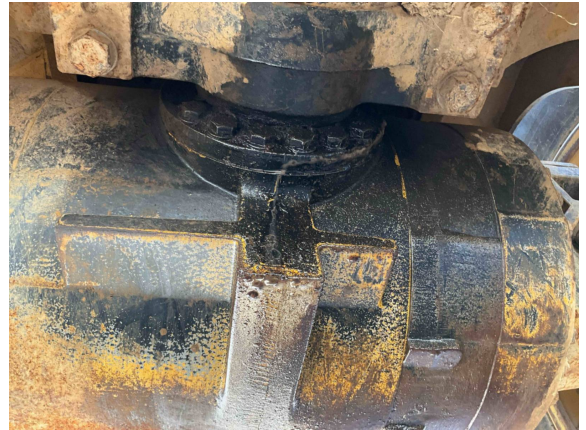
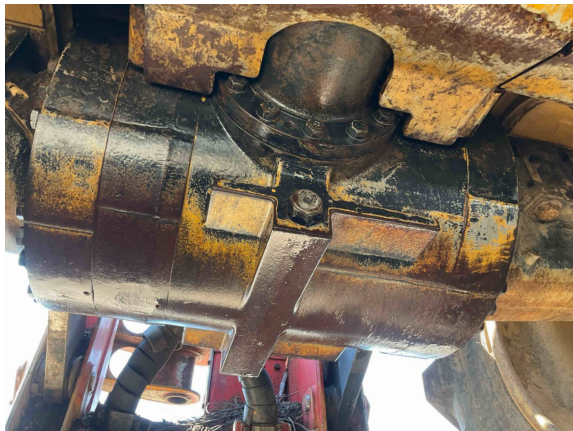
Planetaries / Diff

3
●●
Both front and back differentials are leaking.

●●
Both front and back
differentials are leaking.

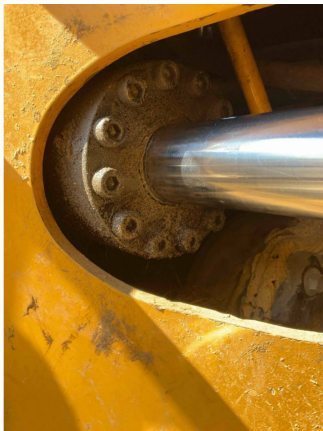
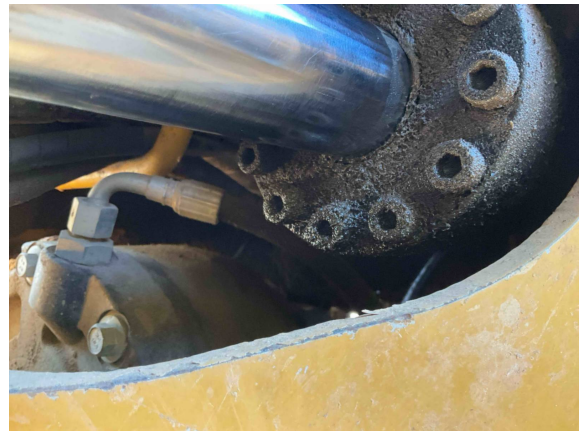
Notes - HYDRAULICS
The cutter head will raise as it should, but will not go down, it is unknown if it is due to codes, or if it is a mechanical issue at the boom. Oth left and right side steering cylinders are leaking.

The cutter head will raise as it should, but will not go down, it is unknown if it is due to codes, or if it is a mechanical issue at the boom. Oth left and right side steering cylinders are leaking.

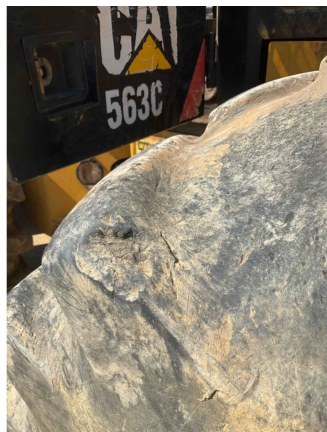
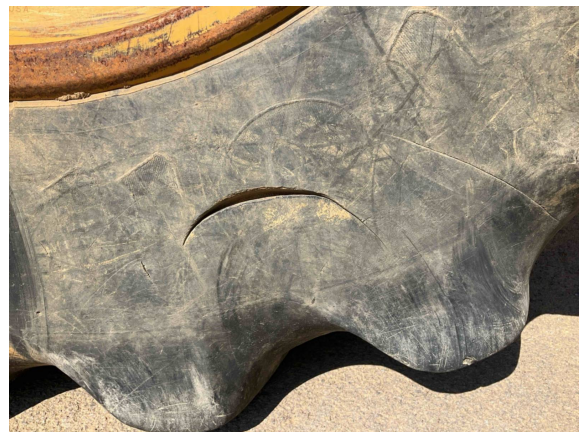
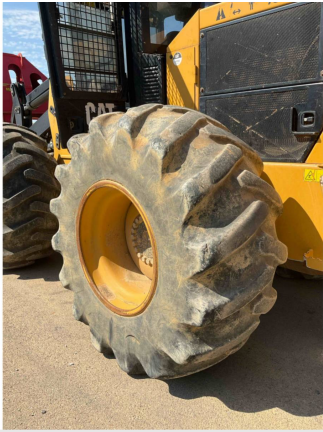
Make / Serial#	Tread Depth in 1/32"	% Life Remaining	Recapped	Tread Cuts/Chunks	Side Cuts Section
Left Rear	Firestone	38	54%	NO	YES	YES

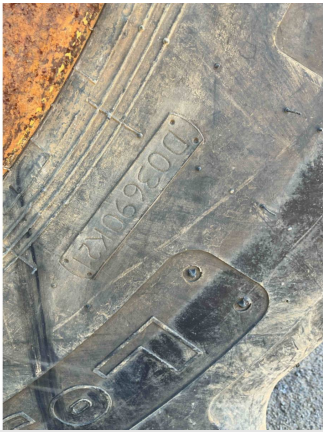
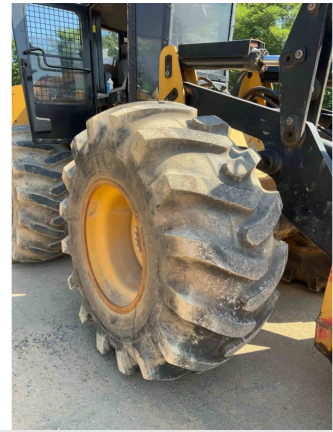
Make / Serial#	Tread Depth in 1/32"	% Life Remaining	Recapped	Tread Cuts/Chunks	Side Cuts Section
Right Front	Primex Logmonster.	55	No specs.	NO	NO	NO

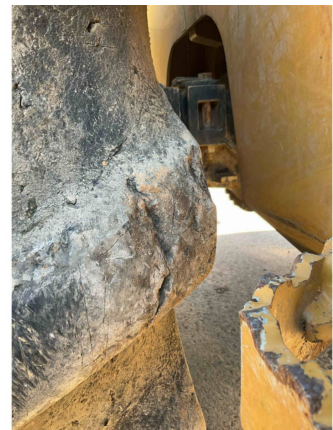
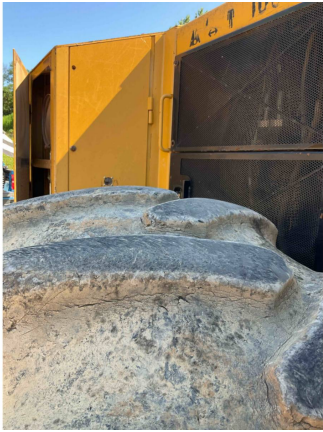
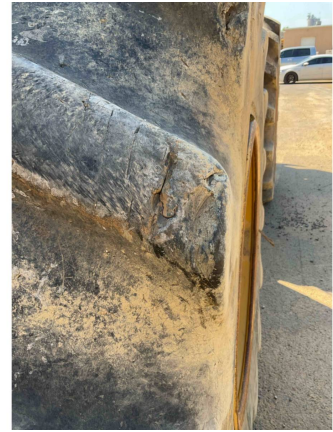
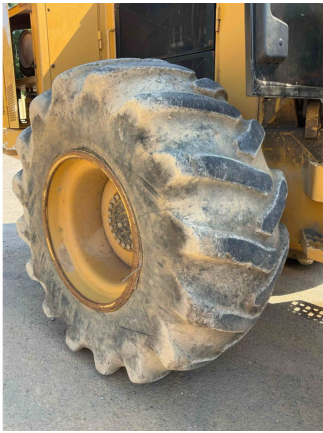
Make / Serial#	Tread Depth in 1/32"	% Life Remaining	Recapped	Tread Cuts/Chunks	Side Cuts Section
Right Rear	Firestone	43	No specs.	NO	YES	NO
