# REPORT OF VESSEL APPRAISAL No. 250501

OF THE SAILING VESSEL  
**Cinco Llagas**  
**2001 Beneteau Oceanus 393**

**CONDUCTED BY**  
**Captain Lyle O. Willson**  
Marine Surveyor & Motor Ship Engineer (R)

Date of Inspection: May 01, 2025.

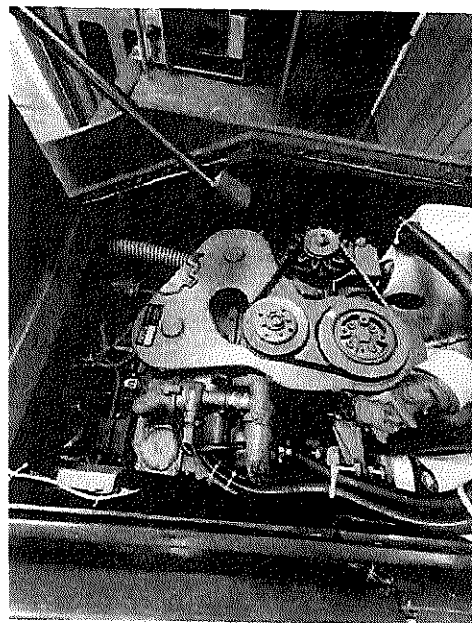
13

| 13) Propulsion engine. | |

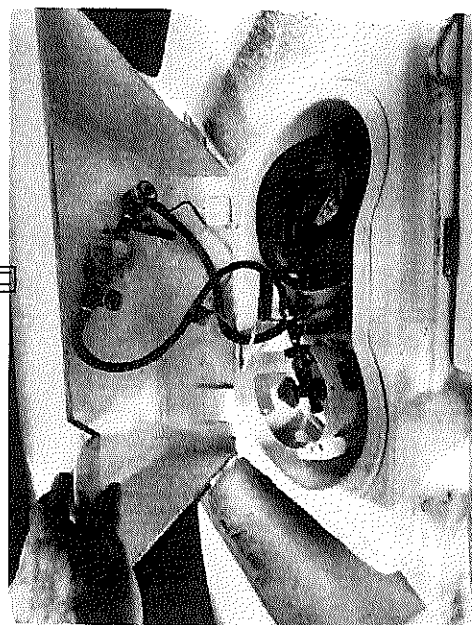
12

**Remarks:** The tanks were secured. The system was not operated or tested.

| 11) AC/DC electrical breaker panels. | 12) Propane locker. |
