2016 CAT 563C FELLER BUNCHERS - WHEEL

INSPECTION DETAILS

Inspection Type	Marketing
Inspection Form	Standard
Inspection #	10141250
Inspection Status	Inspected
Created	08/13/24 08:19:13
Updated	08/13/24 14:28:32
Created By	Newman, Joe D.
Inspector	Newman, Joe D.
Salesperson	Dougherty, Daniel E.
Serial #	W6300278
SMU / Hours	6,325

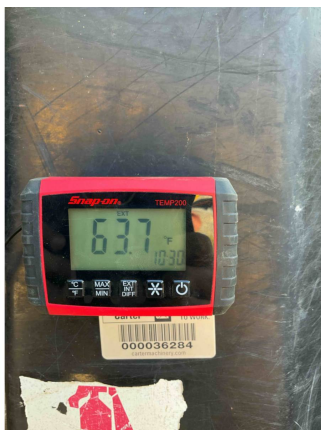
Air Conditioner

Blowing 63 degrees F. Ambient 79 degrees F. There is approximately a 15 degree F. difference.

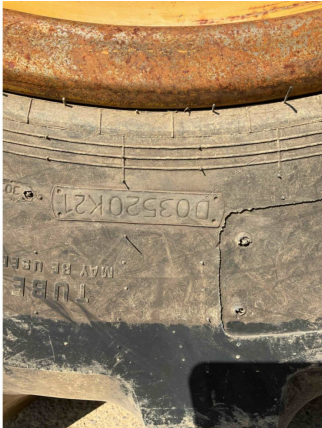
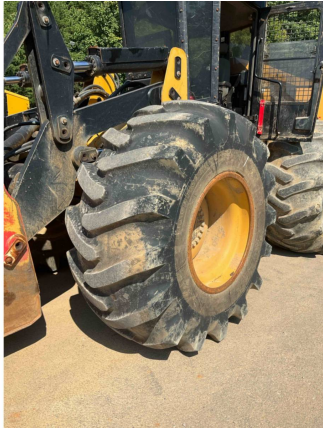
Make / Serial#	Tread Depth in 1/32"	% Life Remaining	Recapped	Tread Cuts/Chunks	Side Cuts Section
Left Front	Primex Logmonster	54	77%	NO	NO	NO

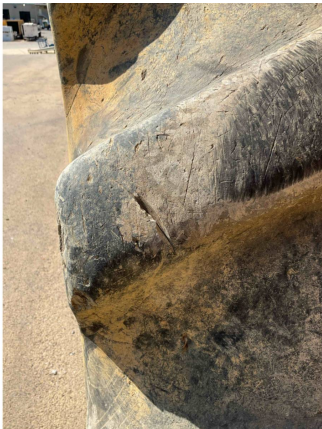
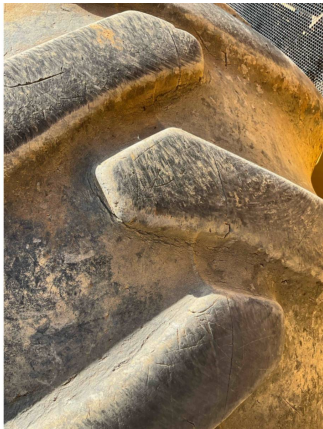
Make / Serial#	Tread Depth in 1/32"	% Life Remaining	Recapped	Tread Cuts/Chunks	Side Cuts Section
Left Rear	Firestone	38	54%	NO	YES	YES

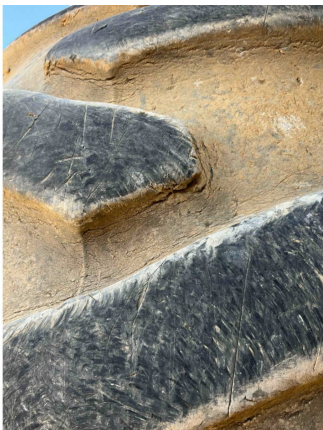
Make / Serial#	Tread Depth in 1/32"	% Life Remaining	Recapped	Tread Cuts/Chunks	Side Cuts Section
Right Rear	Firestone	43	No specs.	NO	YES	NO
