Inspection Report

2011 Hyundai Elantra GLS
VIN: KMHDC8AE7BU107703
Mileage: 218708 km
License Plate:

Courtesy Inspection

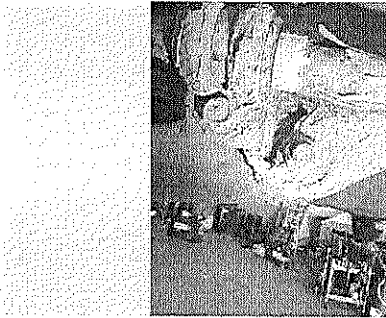
General	Vehicle Condition		NEED IMMEDIATE ATTENTION
---------	-------------------	--	--------------------------

Rear subframe is rusting out badly. Needs rear subframe and everything attached to it. Front subframe is rusting out at the rear right side of the subframe mount.
